# INVESTIGATION ON STRUCTURAL DAMAGES OF RESIDENTAL RC BUILDINGS SUFFERED DUE TO KAHRAMANMARAŞ EARTHQUAKES

**Authors:** TAHA YASİN ALTIOK, CANSU BERİL ESER, BARIŞ  
SERİN, MEHMET ŞEVİK, MEHMET BAKIR BOZKURT, ALİ  
DEMİR

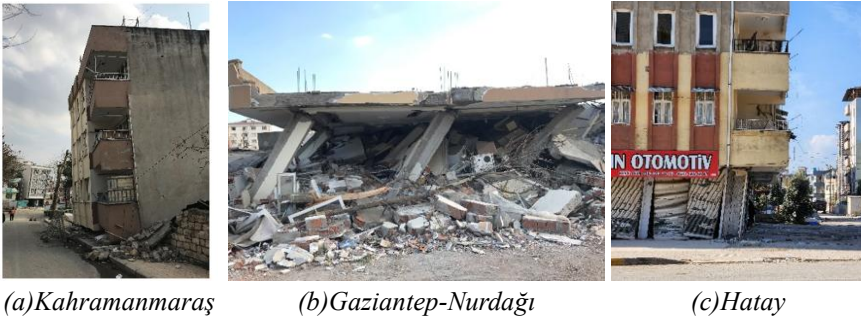
*Figure 11 Observations of damage due to soft/weak story irregularity*

forces. Figure 11 shows buildings damaged due to soft story in Kahramanmaraş, Gaziantep, and Hatay provinces. Collapse due to the presence of soft story is one of the damage types frequently observed in many earthquakes that have occurred in recent years [43]. Soft story irregularity does not always mean poor performance. However, if the ductility demands are not met in the design and the inter-story drifts are not limited, a local collapse mechanism or a story failure mechanism may occur.

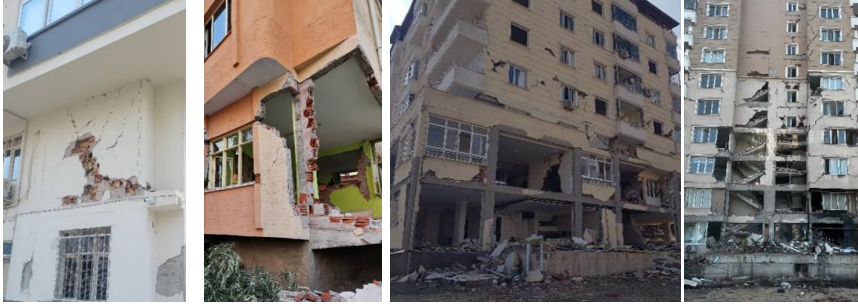
*Figure 12 Observations of infill wall damages*

Infill wall damage is the most observed type of damage in RC buildings in Turkey. This damage consists of interface cracking, diagonal cracking, and crushing at the frame boundary interfaces. Figure 12 shows infill wall damage examples observed in Adana, Osmaniye, Hatay, and Gaziantep provinces. Although infill walls are not considered as structural elements in practice, their dynamic behavior is crucial because they interact with the RC system. Considering the damage suffered by infill walls after the earthquake,

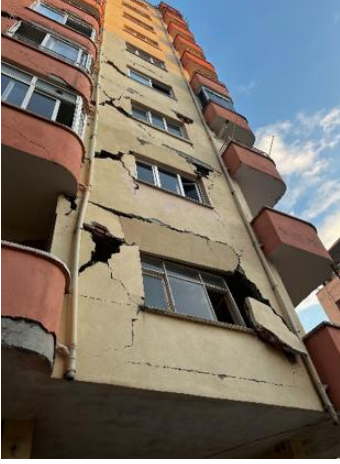
*(a) Osmaniye*

The upper floor plan areas of some buildings differ significantly due to the presence of overhangs. Overhangs made using cantilever beams that carry heavy wall loads are elements that pose a danger to structures in every earthquake. There is no vertical load-bearing element to prevent the lateral translation of the walls on the cantilever beams. For this reason, severe overhang damage occurs. Figure 13 shows the damages caused by heavy overhangs in Osmaniye and Kahramanmaraş provinces. In addition, during an earthquake, cantilever beams suffer serious damage because they lack sufficient rigidity. In areas with overhangs, beams are frequently not built due to architectural concerns, resulting in a lack of beam-column joints. This situation negatively affects the load transfer mechanism. Damages may occur in overhangs due to vertical earthquake accelerations.

*Figure 13 Heavy overhang damages*

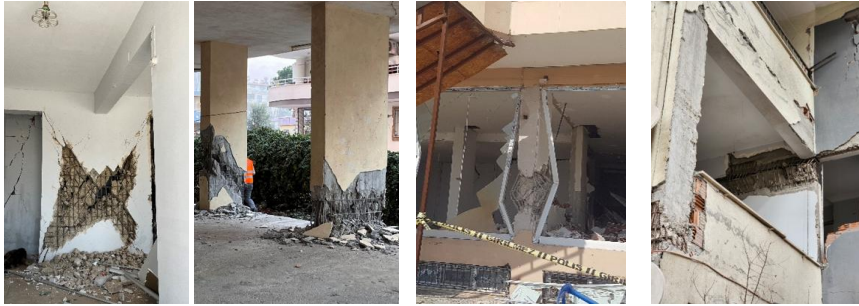
*Figure 14 Columns and shear walls damages*

The columns and shear walls that make up the vertical load-bearing system are crucial elements in terms of maintaining the stability of the structure during the earthquakes. To absorb the shear force that may occur during the earthquake, there must be used sufficient amount, diameter and spacing of stirrups, and concrete with sufficient strength. The wall damages usually occur as X-shaped shear cracks. These damages increase proportionally with the number of floors and height of the building. If the shear wall is weak and the end area is strong, shear cracks occur in the body area. If the column end members are weak and there is no stirrup tightening, large pressure forces occur in the columns due to buckling of the shear wall. Therefore, compressive forces may cause crushing. In addition, insufficient tightening results in buckling of the longitudinal reinforcement in both elements. Columns and shear

walls damages observed during field studies are presented in Figure 14.

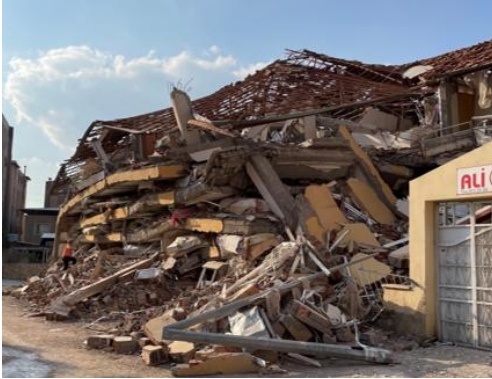
*Figure 16 Strong beam-weak column damages*

Beams are required to undergo deformation before columns to ensure that the structures remain stable under horizontal loads. In order to ensure the strong column weak beam principle, TBEC-2018 requires the column capacity to be at least 20% more than the total capacity of the beams connected to that column, which is one of the main principles of ductile design. Due to some architectural requirements and different reasons, the beams may be larger than the column and are built together with the floor, resulting in high bearing capacity. Column damages before the beams directly affect the stability of the entire structure. For this reason, beams must be designed to be more ductile than columns. In this case, under dynamic influence, the columns undergo plastic hinges before the beams, resulting in partial or total collapse. Damages caused by

strong beams and weak columns observed in Hatay and Kahramanmaraş provinces are given in Figure 16.

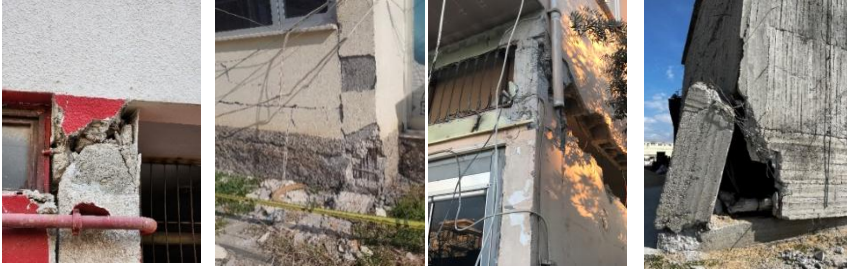
*Figure 17 Short column damages*

In buildings, the short column effect occurs during an earthquake due to ribbon windows, discontinuities in floor beams, and non-load-bearing rigid elements shortening the effective length of columns. The decrease in the net height of the column and the increase in lateral stiffness cause it to be exposed to more than the expected shear force. This may cause serious shear damage to the columns. Short-column damages observed in the seismic zone are presented in Figure 17.

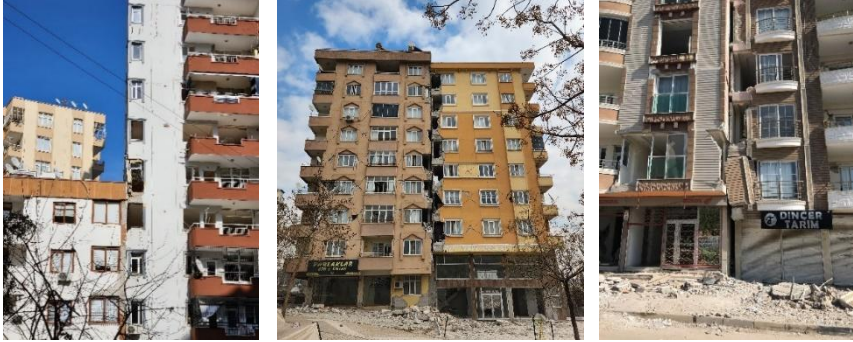
*Figure 18 Damages due to insufficient joint distances*

In our country, there are many adjacent buildings with insufficient expansion joint distances due to architectural and economic reasons. The floor height, building weight, and stiffness of adjacent regular structures differ the dynamic characteristics of the structures. This situation distances the dynamic periods of the structures from each other. These structures with different dynamic behaviors collide with each other due to insufficient joint distance during an earthquake is called the hammering effect. Hammering damages were encountered in many places during field studies, the damages are presented in Figure 18.

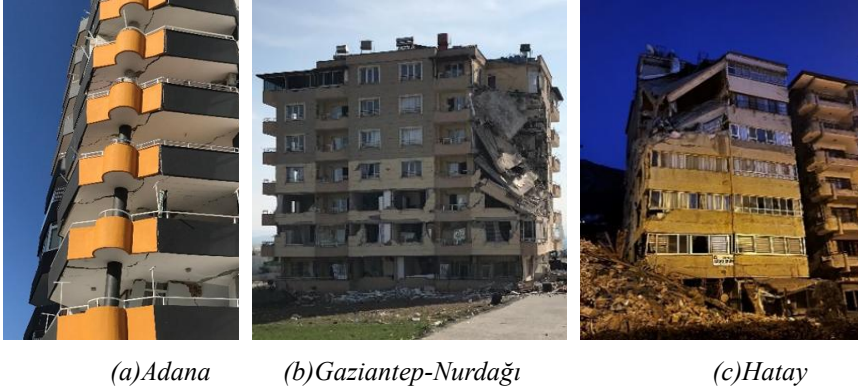
*Figure 19 Corner column damages*

The damage type suffered by unconfined columns that cannot be connected to the frame system of the building due to heavy overhangs during the earthquake is called corner column damage. This damage type usually occurs as a chain collapse of the section around the corner column from the upper floors to the lower floors. Due to the high slab bending capacity, this type of damage can sometimes spread to other parts of the building. Figure 19 shows corner column damage types observed in Adana, Hatay, and Gaziantep provinces.

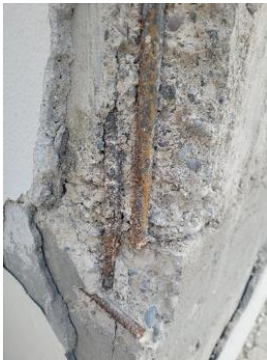
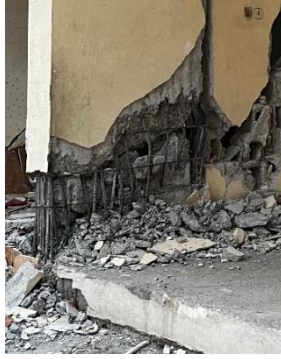
*Figure 20 Improper over-lapping and stirrup hook angle*

During the earthquake, it was observed that sufficient adherence could not be achieved due to short and insufficient stirrup usage at overlaps, and the reinforcement was stripped, resulting in structural damage and collapse (Figure 20). While stirrup hook

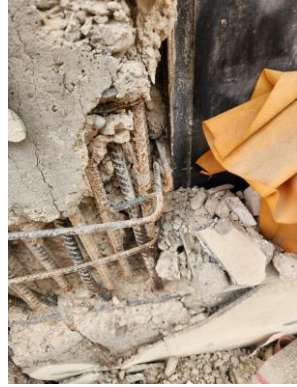
*(c)Kahramanmaraş*

angles were specified as 135° in all regulations from 1975 onwards, the hook angles in many structures were 90° (Figure 20c). Additionally, shear cracks were observed in many structural elements due to the presence of insufficient stirrups in the densification areas. These deficiencies prevented the ductile behavior and caused the brittle damage presented below (Figure 21).

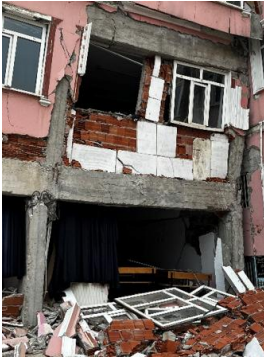
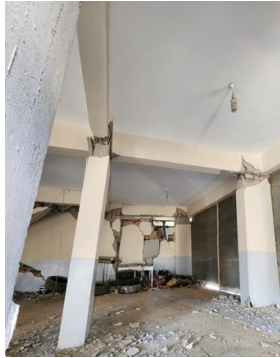
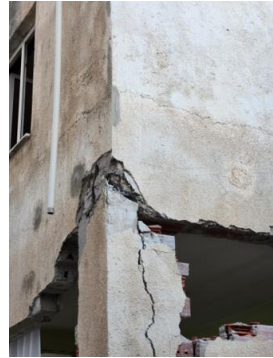
*Figure 22 Column-beam joint damages*

During seismic events, the effects of horizontal forces are concentrated in the column-beam joints. In this case, shear stresses and bending moments occurring in the joint areas may reach limit values. Column-beam joint areas must have sufficient strength and ductility to absorb these effects and consume earthquake energy. Serious damages may occur in the joint areas due to the poor concrete and improper stirrup arrangement. During field studies, many column-beam joint damages were observed (Figure 22). Damages occurring in the column-beam joints may cause partial or total collapse of the structures.

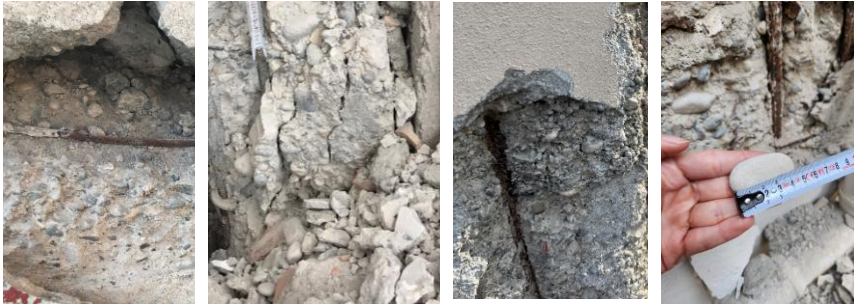
*Figure 24 Damage due to insufficient concrete strength and improper aggregate usage*

One of the most important factors in the earthquake behavior of RC structures is concrete quality. The concrete strength accepted in the project may deviate due to reasons such as the use of dirty materials in concrete, inappropriate grain size, and distribution, adding extra water during the concrete pouring stage, and careless workmanship. During field studies, traces of carbonation were frequently found in porous and hand-crumble concretes with high permeability in Adana, Kahramanmaraş, and Gaziantep provinces. In addition, in the examinations carried out, especially in areas close to the sea and river shores, concretes using large flat-round shaped aggregate particles were found (Figure 24).

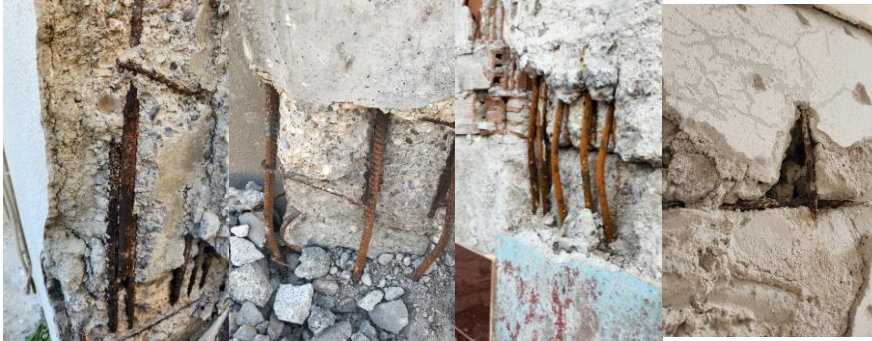
*Figure 25 Corrosion damages*

The most important element required for RC to exhibit a composite structure behavior is to ensure full adherence between concrete and reinforcement. In this case, there will be a constant force transfer between the concrete and the reinforcement, working together. The corrosion is frequently seen in coastal cities, on building exteriors and basements, or in the reinforcement of RC elements where salty sea sand is used. corrosion was generally found in the reinforcement of the load-bearing elements in the basement and on the exterior. Especially in the Adana-Çukurova region, corrosion has been frequently encountered due to the high groundwater level and humidity level of the air in the region. The corroded reinforcements reached a brittleness that could be crumbled by hand, their diameters decreased, and they lost ductile behavior property. Additionally, the stirrups that lost their function during the earthquake opened/ruptured and caused buckling in the longitudinal
