# INVESTIGATION ON STRUCTURAL DAMAGES OF RESIDENTAL RC BUILDINGS SUFFERED DUE TO KAHRAMANMARAŞ EARTHQUAKES

**Authors:** TAHA YASİN ALTIOK, CANSU BERİL ESER, BARIŞ  
SERİN, MEHMET ŞEVİK, MEHMET BAKIR BOZKURT, ALİ  
DEMİR

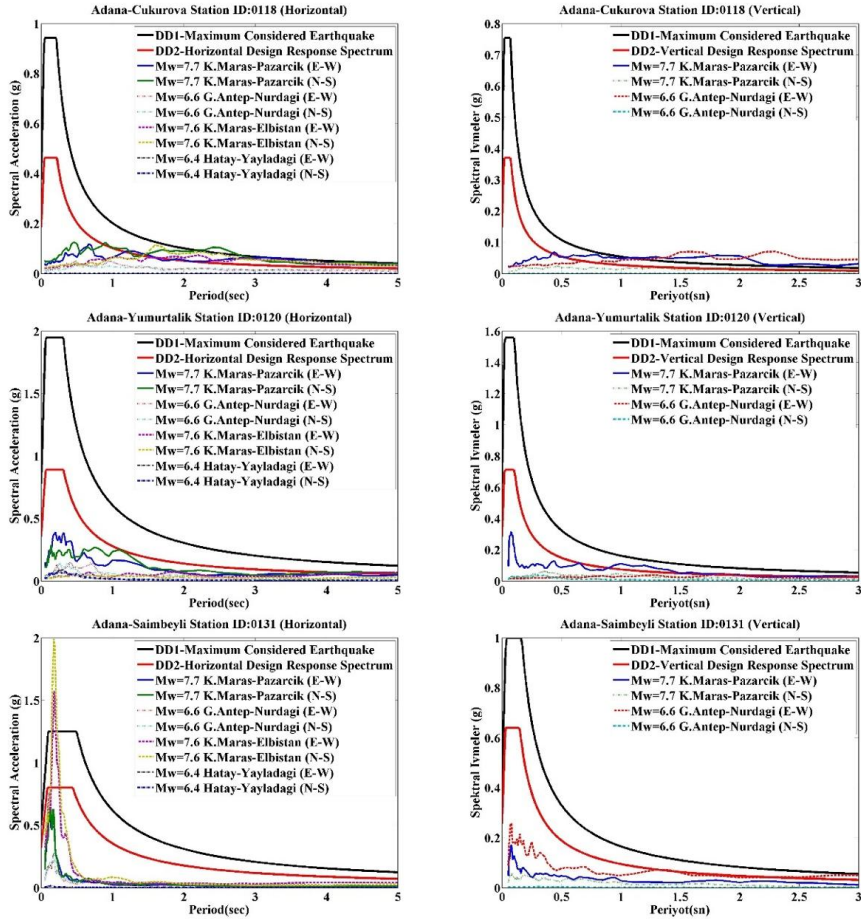
Figure 1 Response spectrum and elastic design spectrum acquired in stations 0118, 0120, and 0131 located in Adana during the earthquakes

The peak ground acceleration value in Adana during the Kahramanmaraş and Hatay earthquakes was read as 0.41g in the east-west direction by the accelerometer placed in Saimbeyli district number 0131 in the Elbistan earthquake. The largest ground accelerations (PGA) and the largest response spectrum accelerations of Saimbeyli district, as well as Çukurova and Yumurtalık districts, are given in Table 2, and the comparison of the response spectrum with the elastic design spectrum is given in Figure 1. As shown in Figure 1, it is seen that the spectral accelerations of station 0118 in Adana Çukurova exceed the elastic design spectrum accelerations in regions where the period is approximately greater than 1.5 seconds, and the spectral accelerations of station 0131 in Saimbeyli exceed the elastic design spectrum accelerations in regions where the period is close to 0.5 seconds.

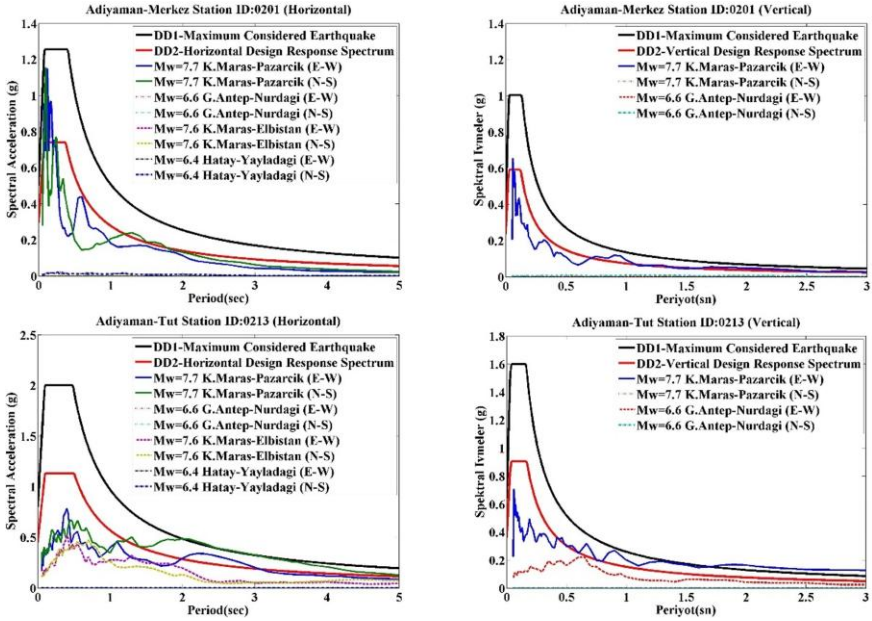
Figure 2 Response spectrum and elastic design spectrum acquired from stations 0201 and 0213 located in Adiyaman during the earthquakes

accelerations of the city center and Tut districts are given in Table 3, and the comparison of the response spectrum with the elastic design spectrum is given in Figure 2. According to Figure 2, the spectral accelerations of station 0201 in Adiyaman Center exceed the elastic design spectrum accelerations in regions where the period is close to 0.5 seconds, and the spectral accelerations of station 0213 in Tut exceed the elastic design spectrum accelerations in regions where the period is greater than approximately 1.8 seconds.

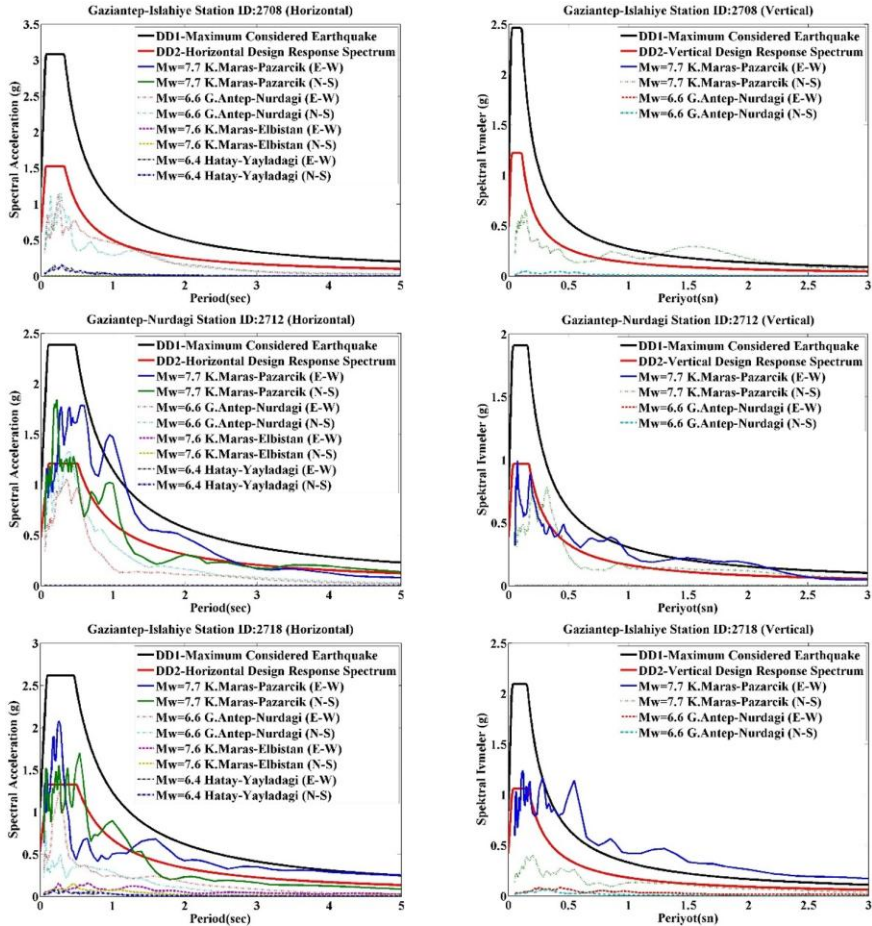
Figure 4 Response spectrum and elastic design spectrum acquired from stations 2708, 2712, and 2718 located in Gaziantep during the earthquakes

the elastic design spectrum is given in Figure 4. According to Figure 4, it is seen that the spectral accelerations of stations 2712 and 2718 in Gaziantep exceed the elastic design spectrum accelerations defined in TBEC-2018 in the region corresponding to many periods.

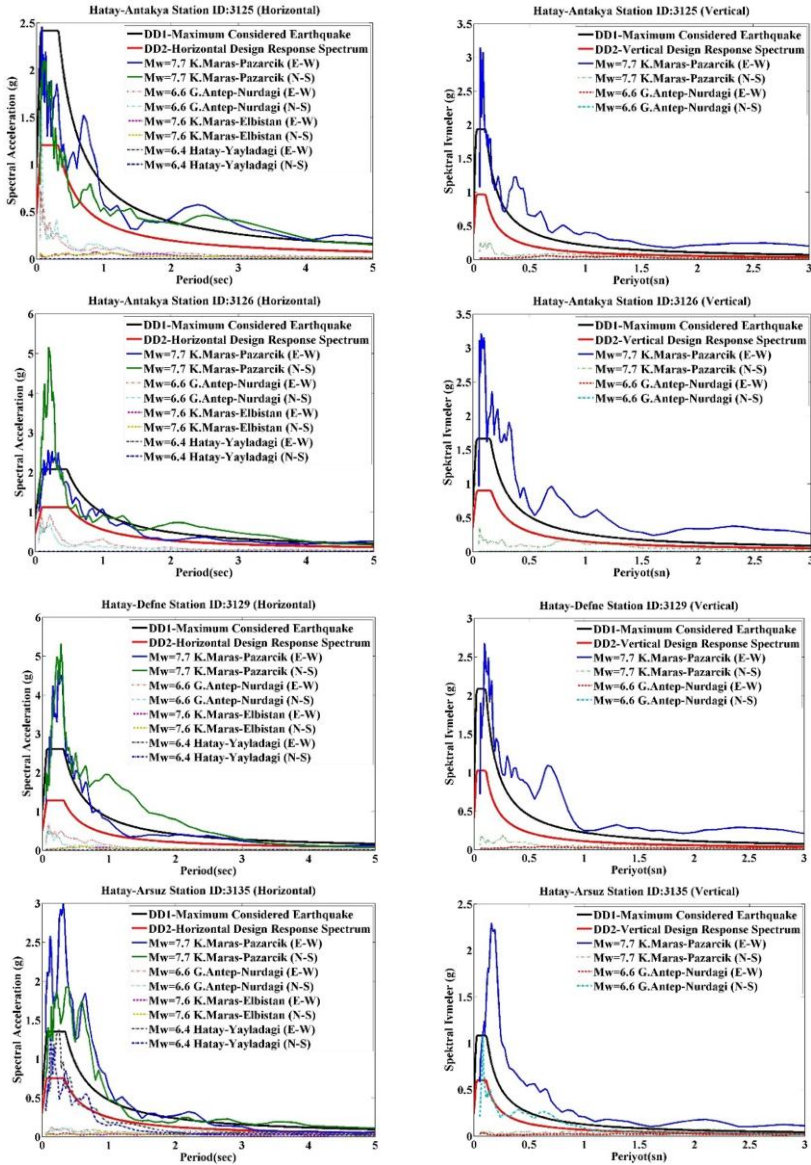
Figure 5 Response spectrum and elastic design spectrum acquired from stations 3125, 3126, 3129, and 3125 located in Hatay during the earthquakes

districts are given in Table 6, and the comparison of the response spectrum with the elastic design spectrum is given in Figure 5. As indicated in Figure 5, it is seen that the spectral accelerations of stations 3125, 3126, 3129, and 3135 in Hatay exceed the elastic design spectrum accelerations defined in TBEC-2018.

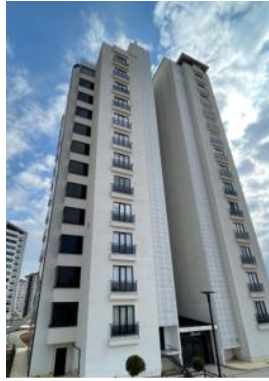
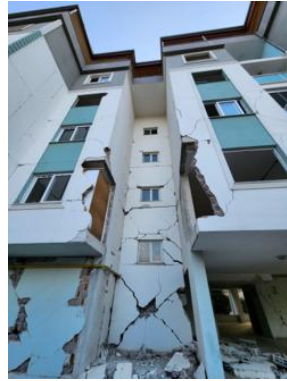
The upper floor plan areas of some buildings differ significantly due to the presence of overhangs. Overhangs made using cantilever beams that carry heavy wall loads are elements that pose a danger to structures in every earthquake. There is no vertical load-bearing element to prevent the lateral translation of the walls on the cantilever beams. For this reason, severe overhang damage occurs. Figure 13 shows the damages caused by heavy overhangs in Osmaniye and Kahramanmaraş provinces. In addition, during an earthquake, cantilever beams suffer serious damage because they lack sufficient rigidity. In areas with overhangs, beams are frequently not built due to architectural concerns, resulting in a lack of beam-column joints. This situation negatively affects the load transfer mechanism. Damages may occur in overhangs due to vertical earthquake accelerations.

*Figure 13 Heavy overhang damages*

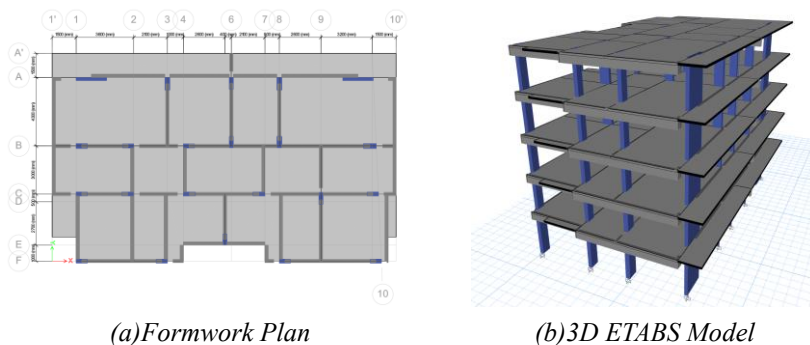
*Figure 29 Structure Model: Formwork Plan of the Investigated Structure - 3D ETABS Model of the Investigated Building*

The building in examination, which was designed in compliance with the 1975 Turkish Earthquake Code and constructed in 1990, collapsed during the earthquake that occurred on February 6, 2023. The structure consists of a ground story and four normal story, with a total height of 15.3 meters. The height of the ground story is 3.7 meters, while the other stories have a height of 2.9 meters each. The ground story is designated for commercial use. The formwork plan and 3D ETABS model of the structure are presented in Figures 1. The structure was modeled in the ETABS program based on the existing archival project. The concrete class of the structure was determined through core samples taken from the building. In Turkey, older structures with ground stories designated for commercial use typically exhibit infill wall ratios between consecutive stories that do not comply with the thresholds defined in the building codes. This situation increases the likelihood of weak/soft story irregularity occurring in the examined structure. Despite the structural design indicating a concrete class of C14, tests

conducted on core samples demonstrated that the existing concrete strength is merely 8 MPa. The rebar class was determined as S220. Upon examining the formwork plan presented in Figure 29, it is evident that frame discontinuities are present. In addition, significant variations in column dimensions were identified; while the columns on the ground story have a cross-section of 30/80 cm, they were observed to reduce to 25/50 cm on the upper stories. The structure's period in the x-direction is 0.972 seconds, with a modal participation ratio of 78.5%, and in the y-direction, it is 1.374 seconds, with a participation ratio of 81.7%.

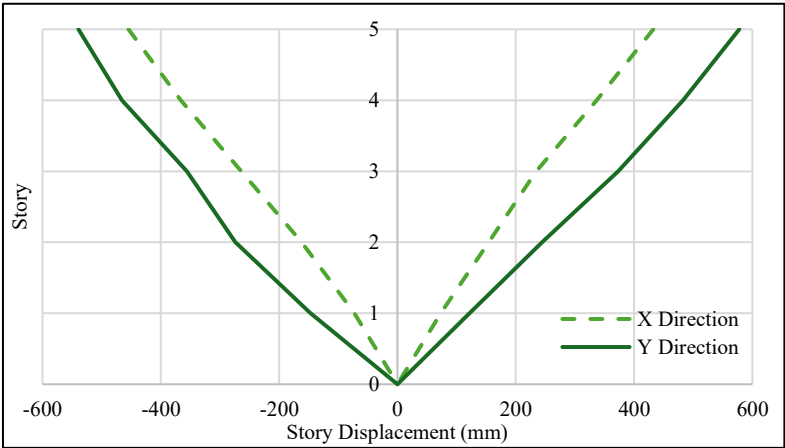
Figure 37 Story Displacements

When examining the story displacements, it was determined that the displacement values at the roof level of the structure exceeded 400 mm (Figure 37). In terms of story drifts, it was observed that the drift ratio reached nearly twice the critical threshold of 2% (Figure 38). The acceleration experienced at the roof level was found to be above 4g (Figure 40). Additionally, torsional irregularity was identified in the structure, with the limit value of 1.2

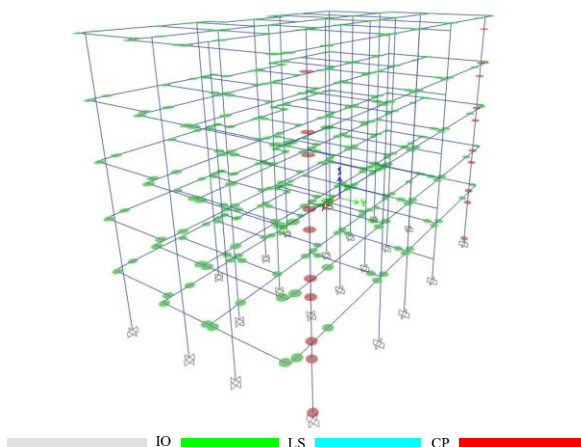
Figure 41 Performance Levels of Structural Elements

specified in TBEC 2018 being exceeded by 21.5% (Table 12). When the performance analysis results are examined, it is concluded that the presence of two brittle column elements on each story increases the risk of collapse of the structure. Additionally, significant damage was observed in the beam elements due to inadequate column-beam connections (Table 13-Figure 41).

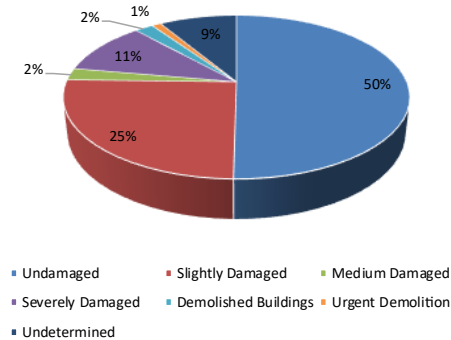
*Figure 46 Damage assessment status [48]*

Immediately after the earthquake, damage assessment studies were carried out by the Ministry of Environment, Urbanization, and Climate Change. Figure 46 shows the percentages of the structural conditions obtained in the damage assessment study conducted on March 6, 2023. However, approximately 50% of the structures in the region could not be identified initially. According to the findings, 2%

of the buildings were found to be undamaged, 25% were slightly damaged, 2% were moderately damaged, 11% were heavily damaged, 9% were destroyed, and 1% were to be demolished urgently.

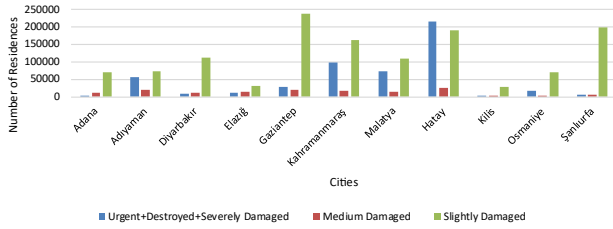
Figure 50 Damage assessment status of buildings in the seismic zone [48]

According to damage assessment studies, province-based detection situations are given in Figure 50 in quantity and Figure 51 in proportion. According to the graphs, it can be seen that the greatest destruction and heavily damaged structures are in the provinces of Hatay, Kahramanmaraş, Malatya, and Adıyaman.
