FORMATION MODELS *OF* KONYA SINKHOLES AND THEIR RELATION TO EARTHQUAKES

THE RELATIONSHIP BETWEEN SINKHOLES AND EARTHQUAKES IN THE KARAPINAR REGION (KONYA-CENTRAL ANATOLIA)

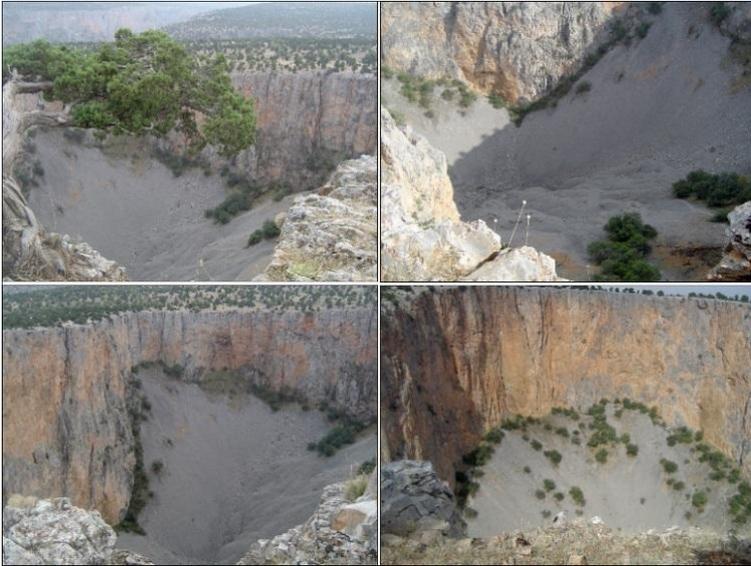
Figure 6: Colluvial deposits accumulated at the base of the Belkuyu Sinkhole.

The sinkhole exhibits steep walls, while its base is observed to be infilled with block collapses and colluvial deposits originating from the surrounding lithologies (Figure 6).

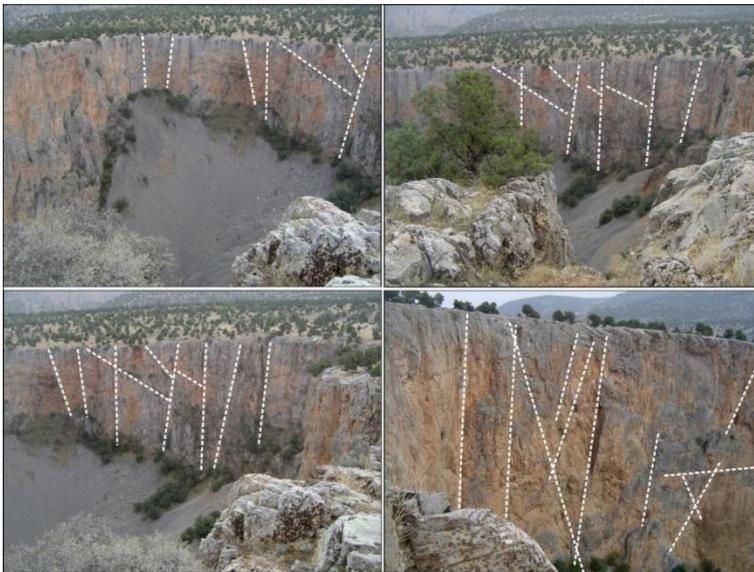
Figure 7: The walls of the Belkuyu Sinkhole exhibit multiple joint sets with differing orientations and dip angles.

As a result of the observations made on the walls of the sinkhole, joint sets with different orientations are observed (Figure 7). Most of these fracture sets have a steep, while a few have a low-angle slope. Fractures have a great influence on the formation of karst structure.
